SERVICE BULLETIN

This is to inform you of a possible problem concerning Daytona 2 USA 'DLX versions'.

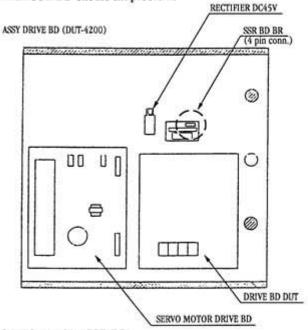
PROBLEM: Cabinet won't move and/or brake won't disengage.
CAUSE: Incorrect wiring on SSR BD.

Setup of JST 4 pin plug for low voltage located on SSR BD.

SOLUTION: Correct wiring layout on SSR BD should fix problem.
