SEGA SERVICE

Field Service Bulletin Brave Firefighter Nozzle Assembly Parts Advisory

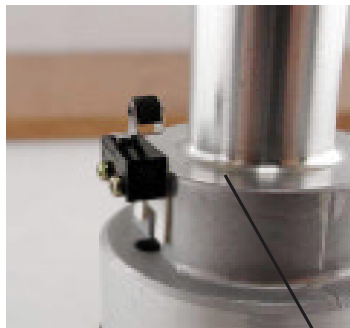
Nozzle Assembly Drawing showing placement of FRQ-2709

Problem: Micro-switch (Spray Select) breaks causing players not to be able to control spray type. Problem occurs in newly purchased replacement Nozzle Assy.

Washer (FRQ-2709) MUST be on this surface to assure no damage to the Micro-Switch.

Solution: Verify Washer (FRQ-2709) is installed on the assembly. See figures below. If Washer is missing, please contact your Sega Parts Distributor to obtain the washer.
